LIGHTWEIGHT GEARBOX COMPOSITE CASE.
PHASE II.

**PHASE II
LIGHTWEIGHT GEARBOX
COMPOSITE CASE**

**FINAL REPORT
(18 MARCH 1970 TO 18 JANUARY 1971)**

**Detroit Diesel Allison Division • General Motors
Indianapolis, Indiana**

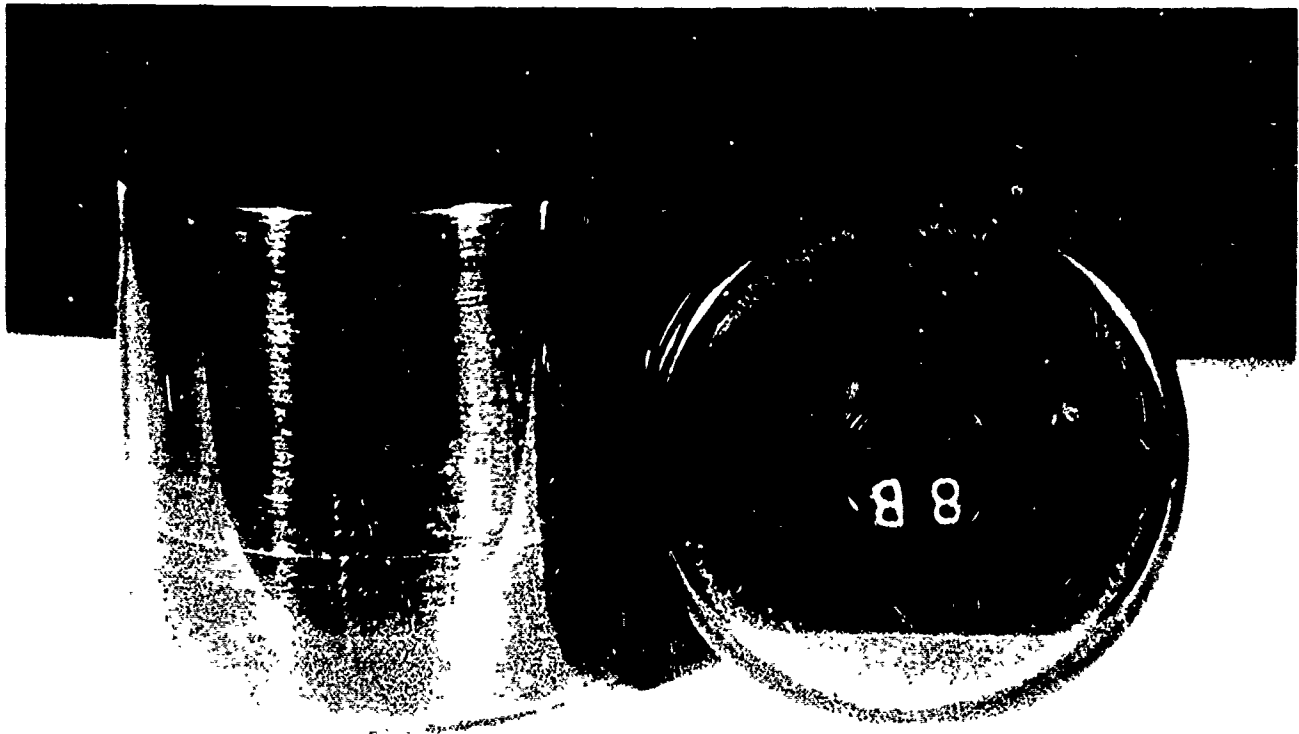
FIGURE 18 MAIN DRIVE GEAR BEARING SUPPORT - INNER RACEWAY AND ROLLERS
(AFTER TEST)

Photographs of these same components after the testing indicated that their condition was unchanged. This fact leads to the conclusion that the stiffness of the composite material front gear case was adequate in reacting the imposed loads to maintain proper gear and bearing alignment.

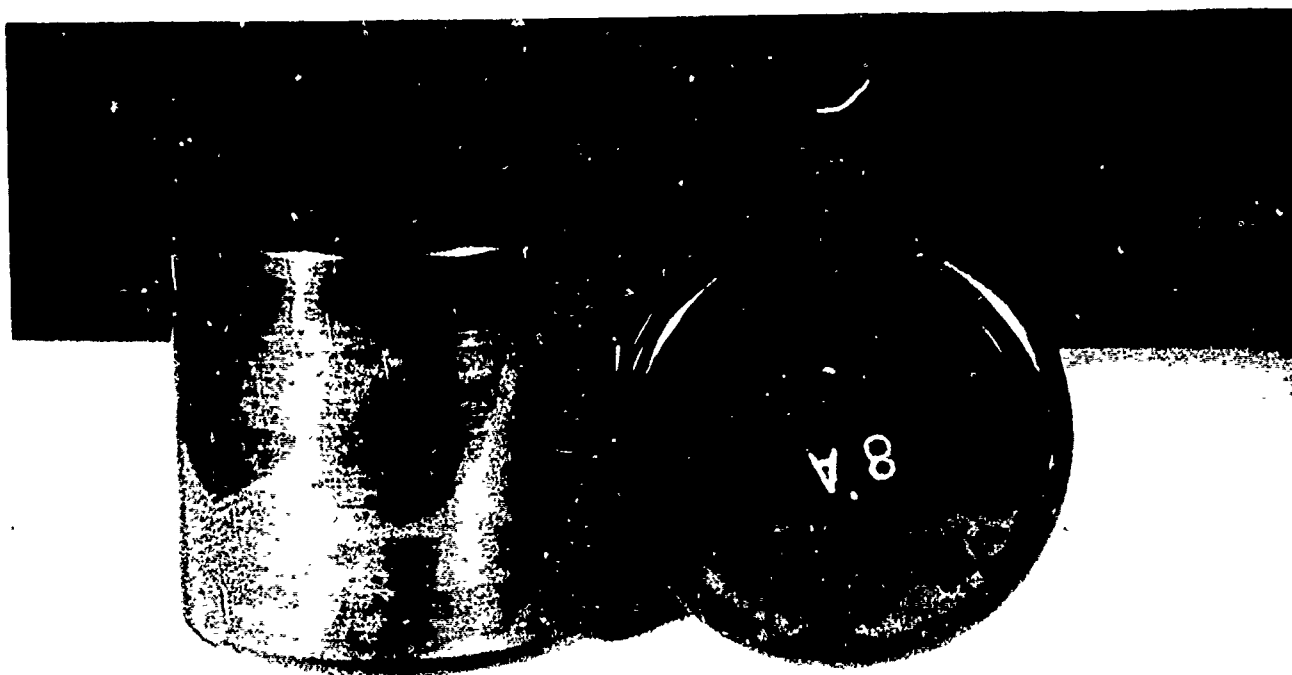
FIGURE 22 MAIN DRIVE GEAR SUPPORT-PROPELLER BEARING OUTER RACEWAY AND ROLLERS (AFTER TEST)

These photos are grouped in pairs (before and after condition) and are given in Figures 21 through 24 and Figures 27 through 32.

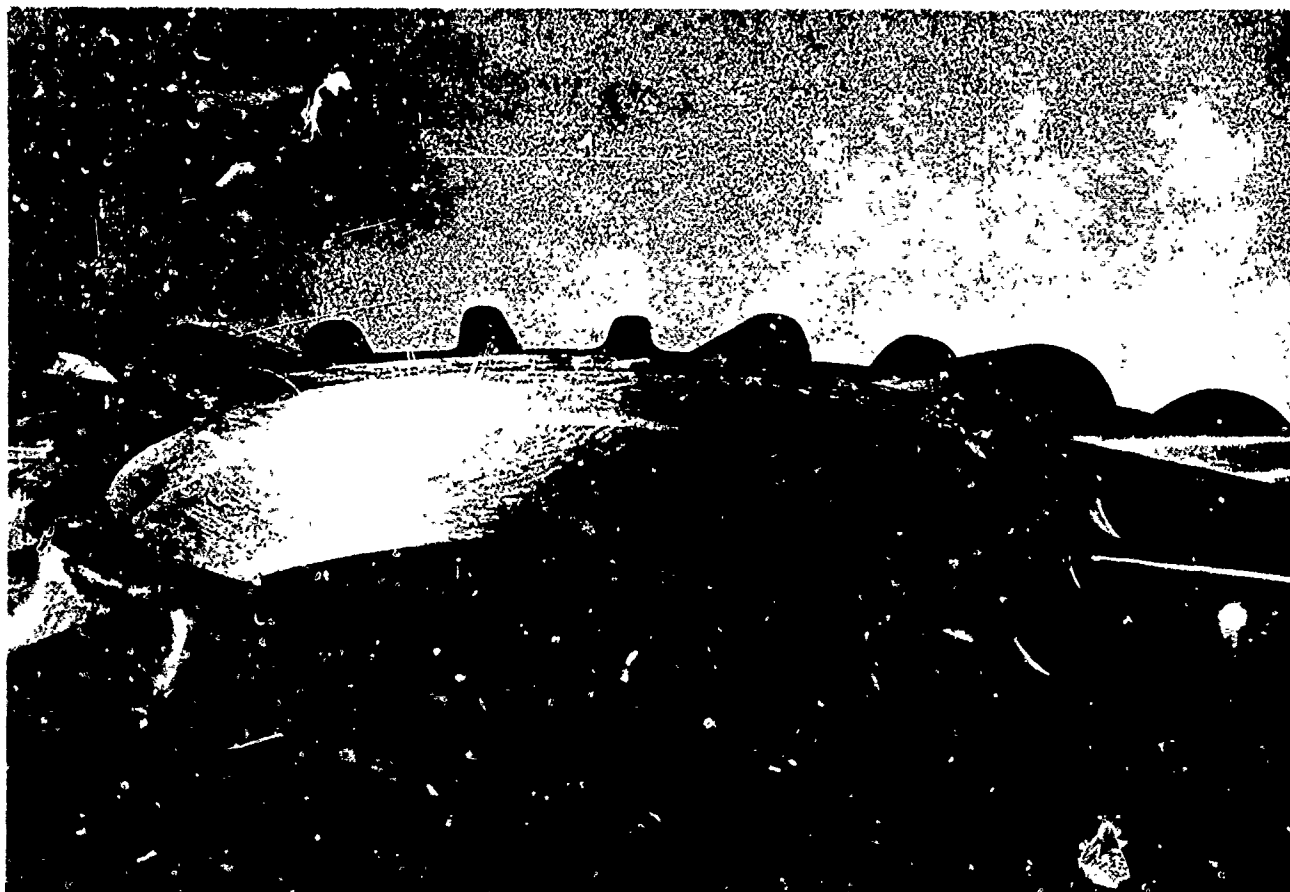
FIGURE 33 COMPOSITE CASE FOLLOWING DYNAMOMETER TEST

Two defects were noted in the case after testing. Minor cracks appeared at the junction of the internal stiffening ribs to the case shell at the main splitline. A prism of filler material was ejected from the case at the front seal mounting surface as revealed by Figure 33. These defects do not seriously reflect upon the suitability of the composite material for future development work.

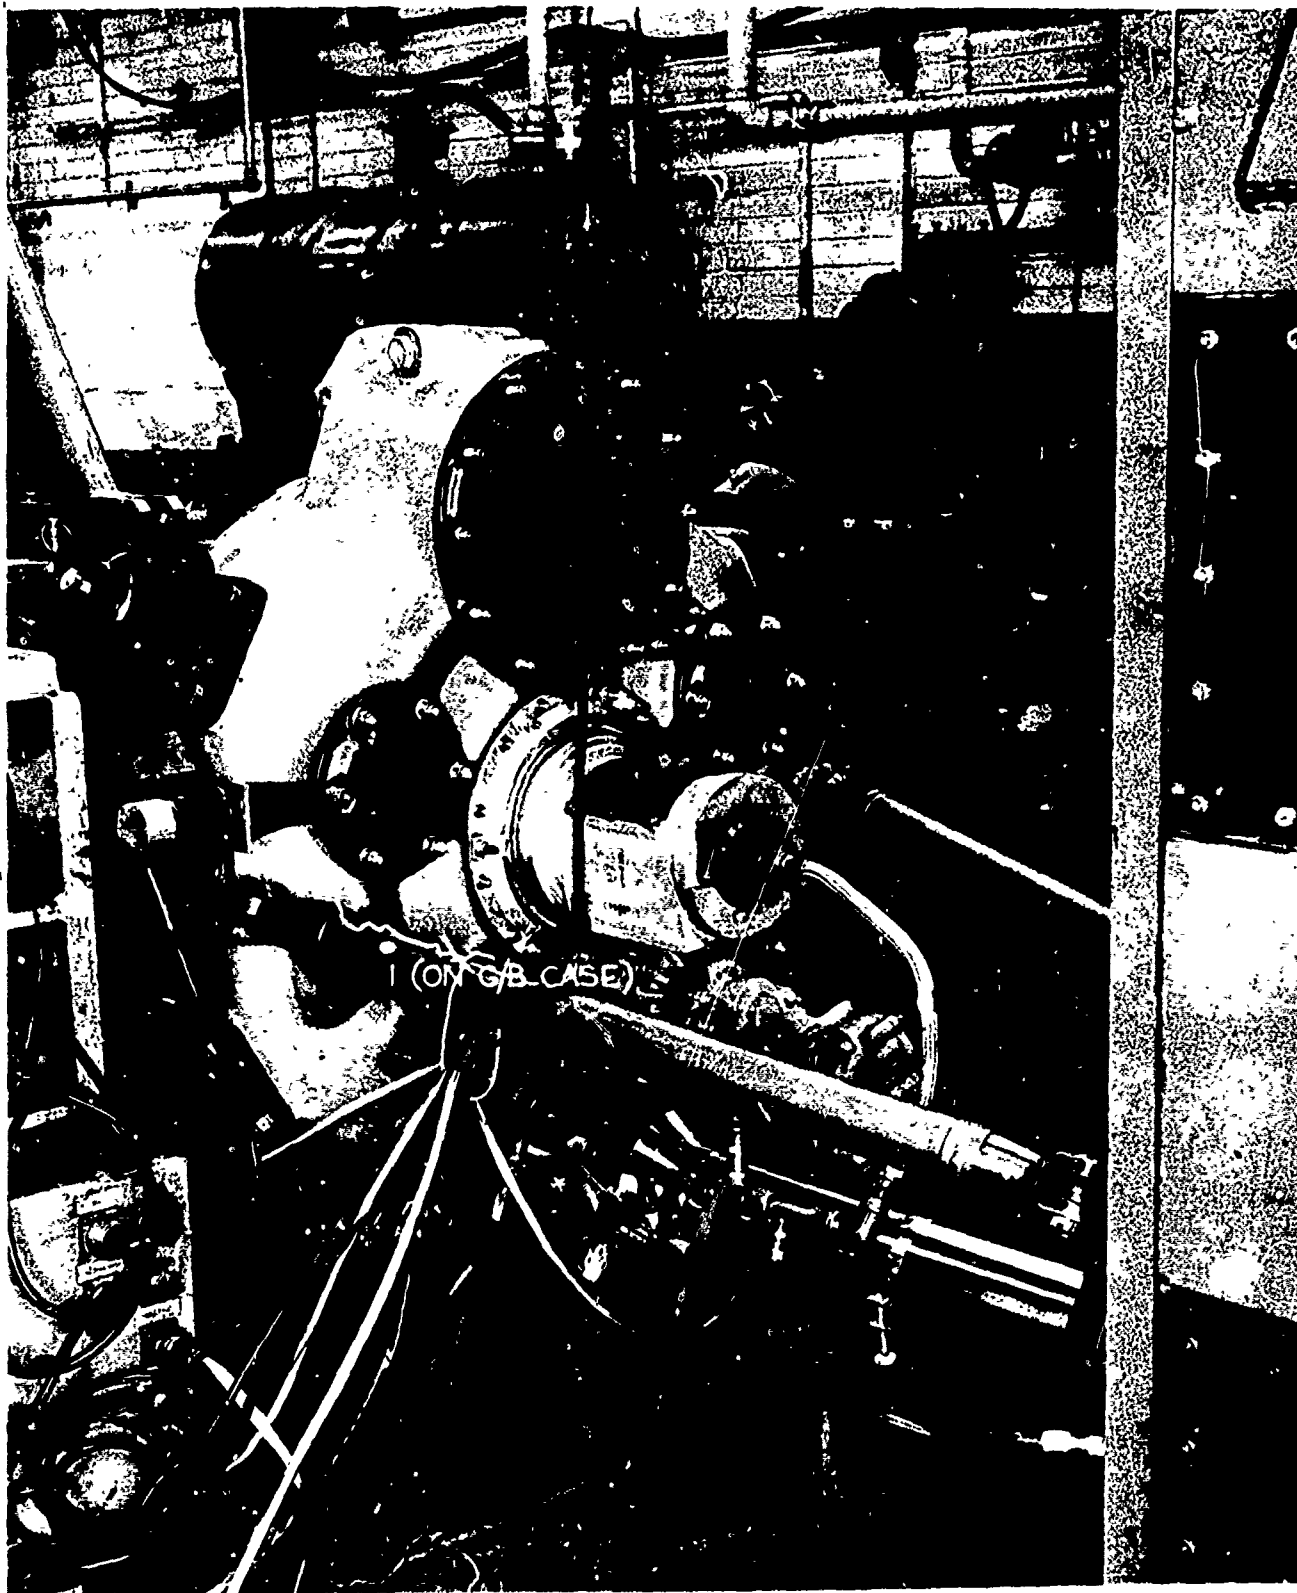
FIGURE 34 TRANSDUCER LOCATIONS-VIBRATION SURVEY COMPOSITE CASE

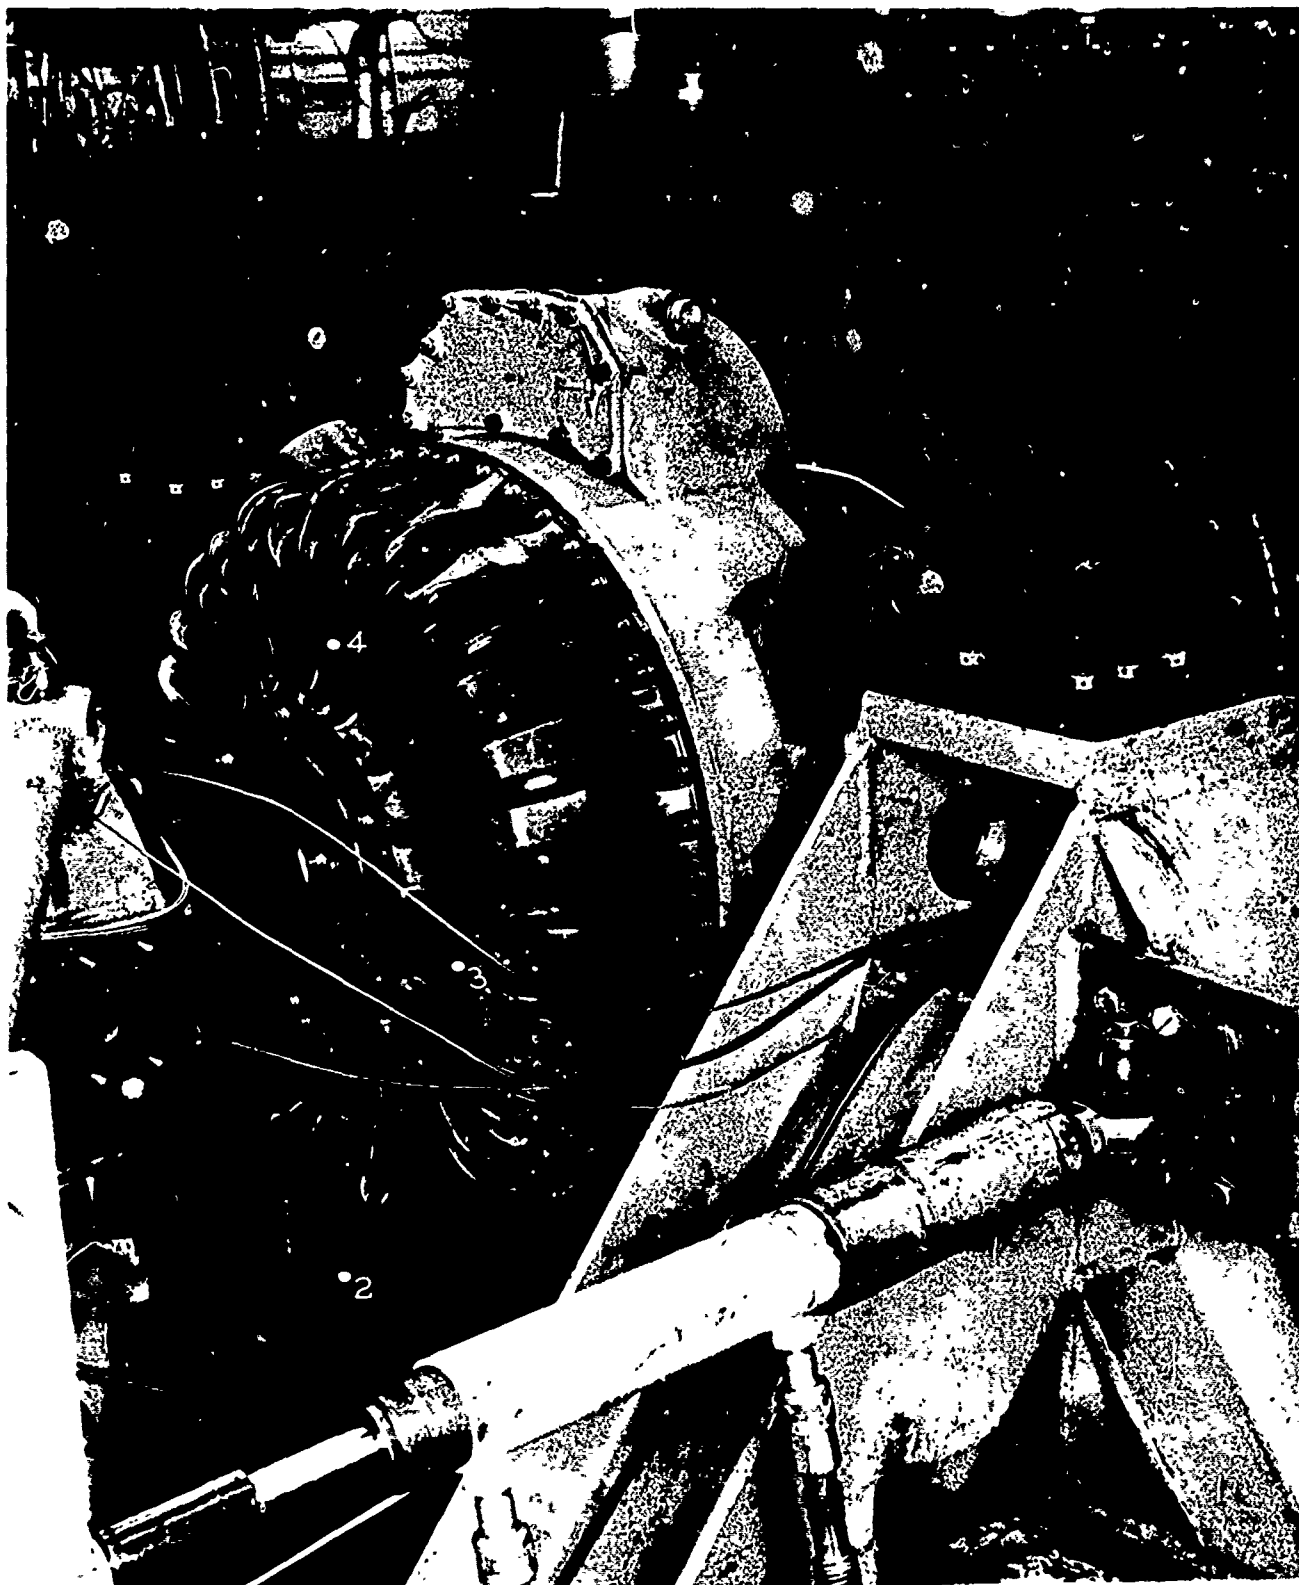
FIGURE 35 TRANSDUCER LOCATIONS-VIBRATION SURVEY COMPOSITE CASE

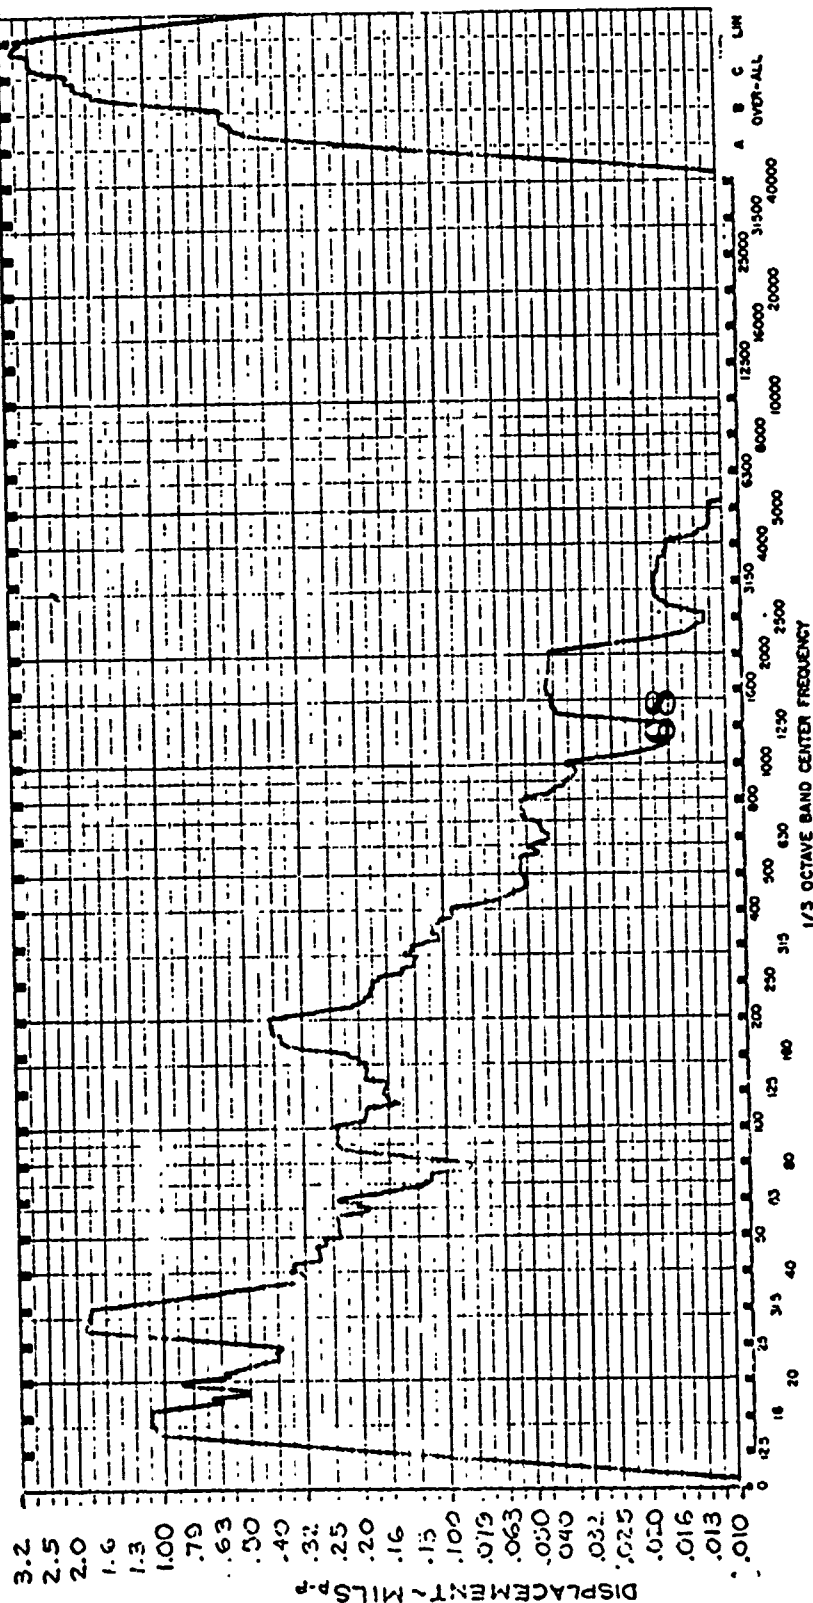
CURVE NO. 14

ER NO 16 P.P. 4

G/B FRONT CASE TOP F&A
12,530 RPM = 209 Hz
PROP ROTATIONAL = 15 Hz

After the vibration pickup was bonded to the case, the dynamometer was brought up to rated speed and 200 HP applied to the prop shaft. The dynamometer RPM was reduced to 6,000 RPM and then slowly accelerated to 15,200 RPM. Vibration and RPM were recorded on the X-Y recorder during the acceleration. Points of high vibration, indicating a possible resonant condition, were investigated using the 1/3 octave analyzer.

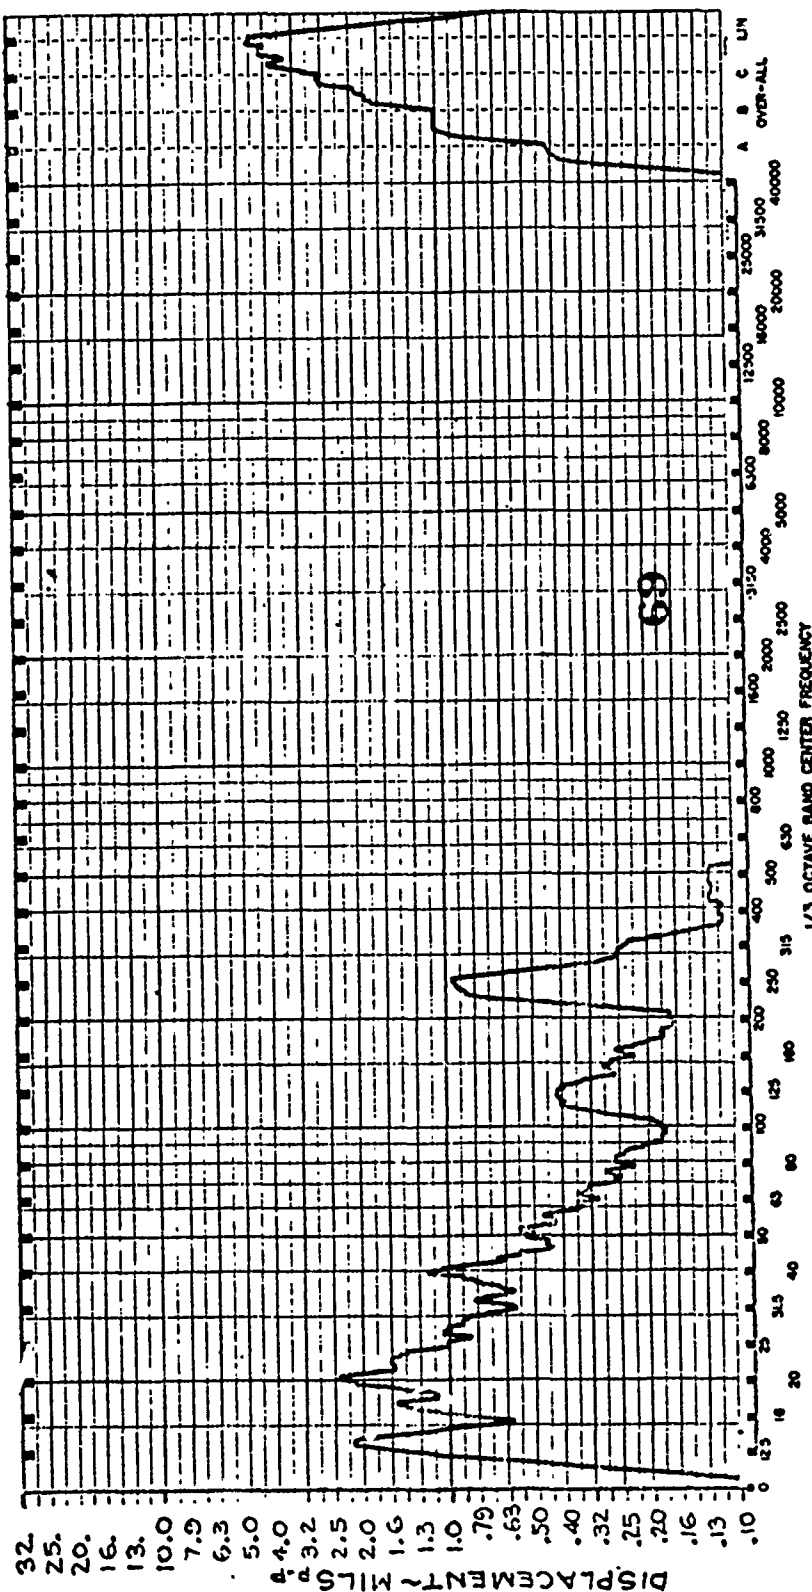
CURVE NO. 15

ER NS. 17 P.P. 4

G/B FRONT CASE TOP FEA
15,180 RPM = 253 Hz
PROP ROTATION = 19 Hz
